SU1474710000, INDIAN RIVER FARMS LAKE #3, 979833, 2017-04-10

Overall Information

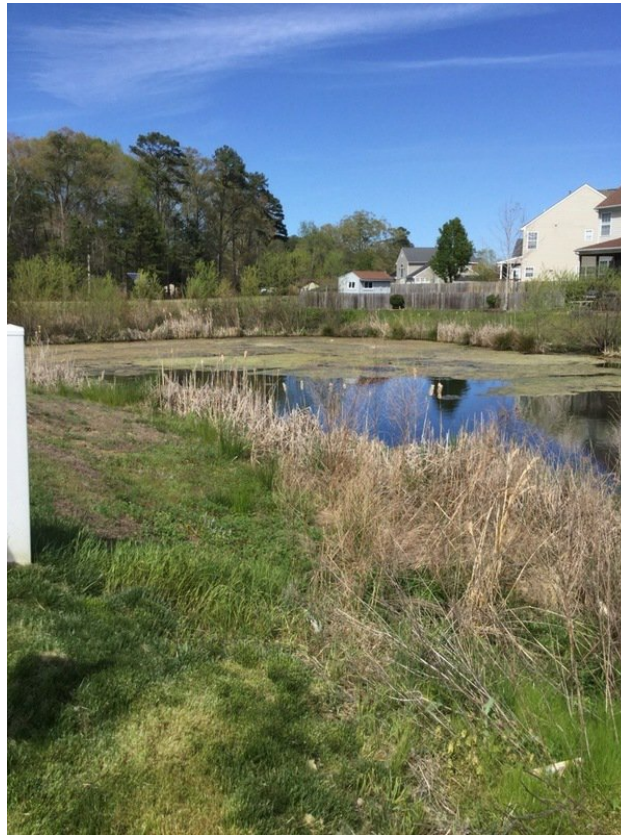
Evidence of overgrowth of algae

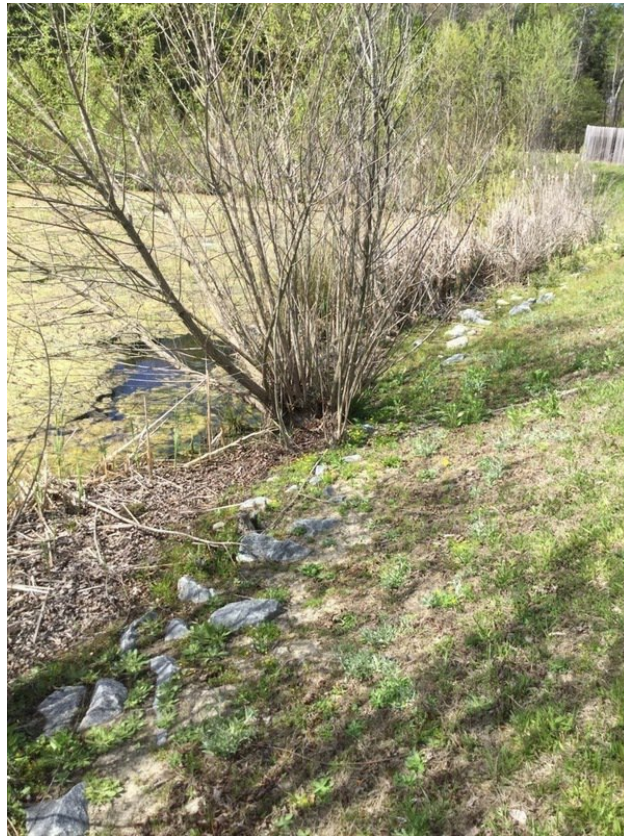
Pre-treatment Grass Filter Strip Defect Type Photo

Pre-treatment Grass Filter Strip Defect Type	Vegetation
Pre-treatment Grass Filter Strip Defect Type Score	1 = Moderate condition. Adequately maintained, routine maintenance needed.

Some woody vegetation that may lead to future erosion

Pre-treatment Grass Filter Strip Comment	Some woody vegetation that may lead to future erosion
2 - First Highest Pre Treatment Grass Filter Strip Score and Defect type	1 - Vegetation
2 - First Highest Pre Treatment Grass Filter Strip Score	1
3 - SIDE SLOPE INSPECTED	Yes

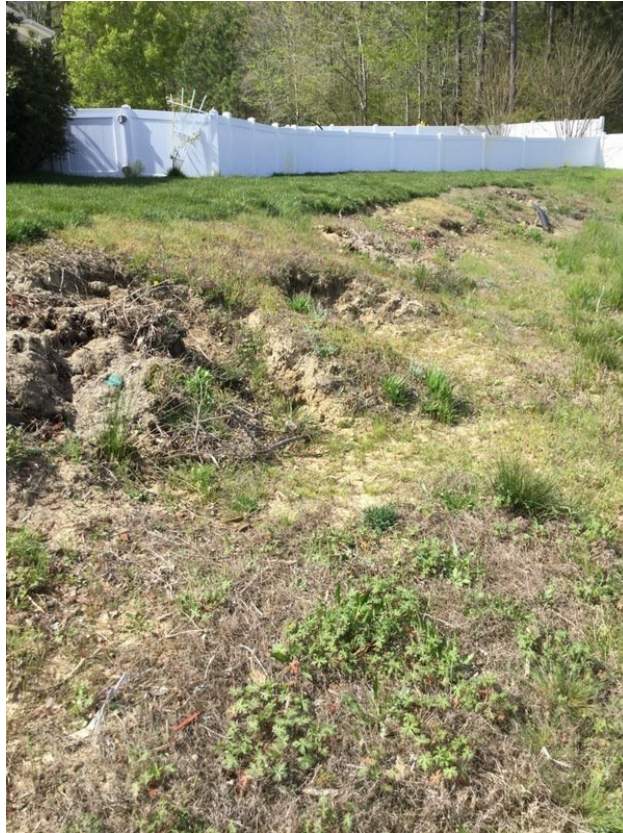
Side Slope Defect Type Photo

Side Slope Defect Type	Erosion
Side Slope Defect Type Score	2 = Degraded condition. Poorly maintained, routine maintenance and repairs needed.

Large amount of erosion on side slope

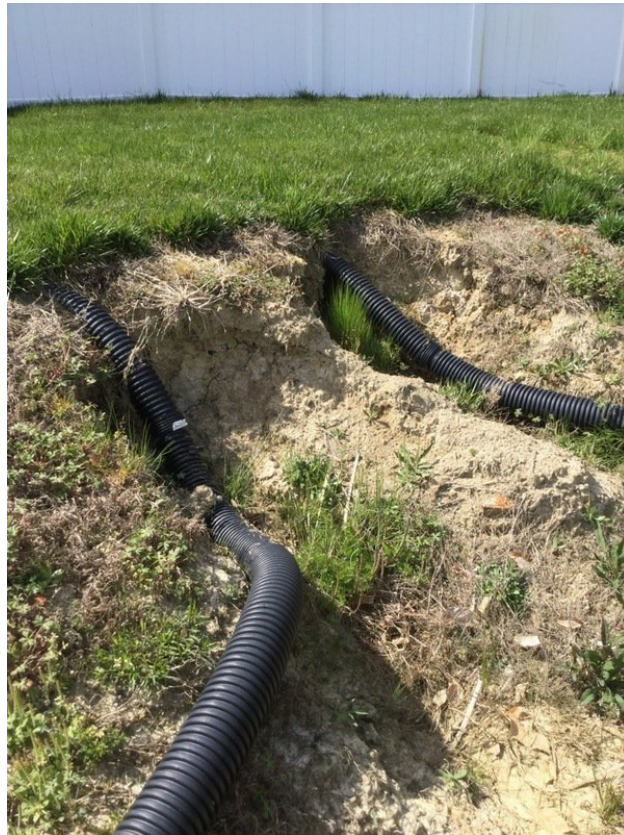
Side Slope Defect Type Photo

2 = Degraded condition. Poorly maintained, routine maintenance and repairs needed.

Private residence inlet may be causing erosion

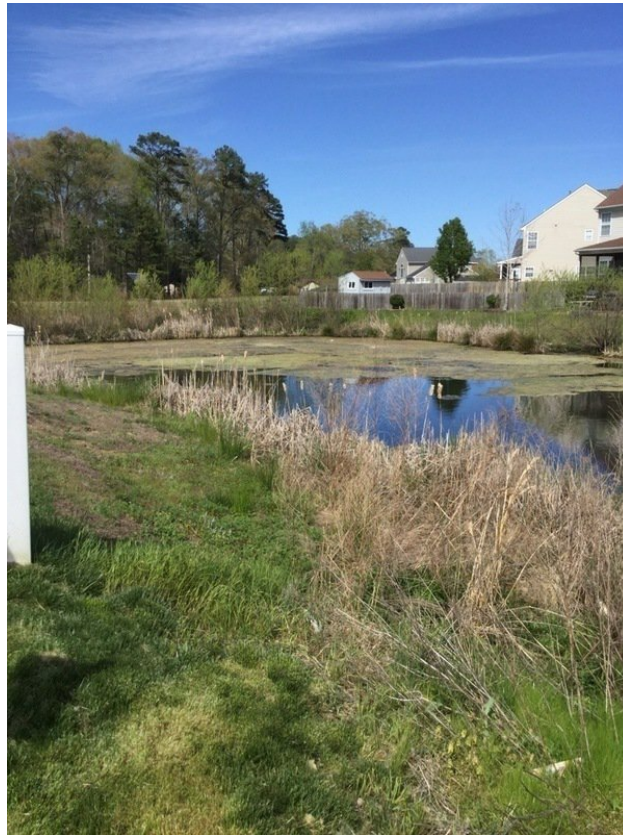
Side Slope Defect Type Photo

2 = Degraded condition. Poorly maintained, routine maintenance and repairs needed.

Evidence of overgrowth of algae

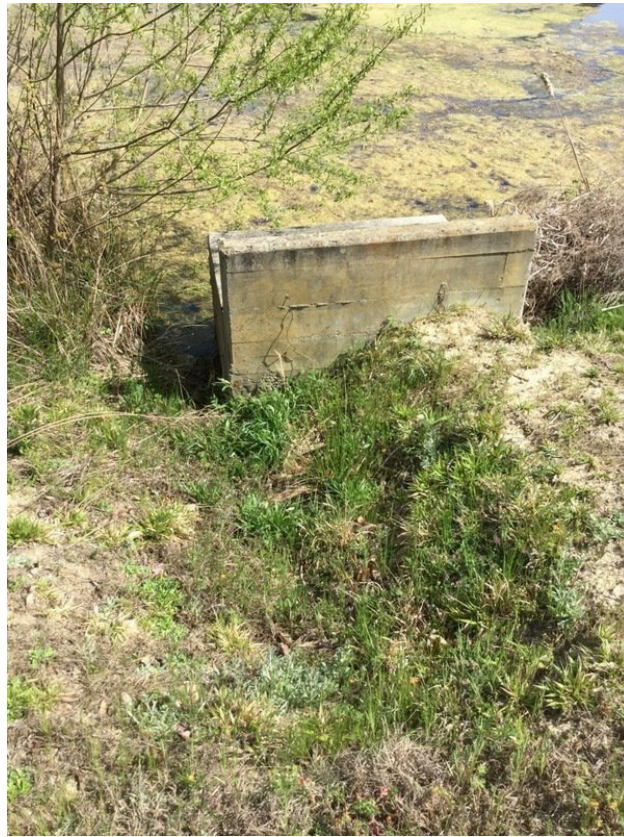
Riser Principal Spillway Defect Type Photo

Riser Principal Spillway Defect Type	Erosion
Riser Principal Spillway Defect Type Score	1 = Moderate condition. Adequately maintained, routine maintenance needed.

Erosion on sides of riser F12509- 1023

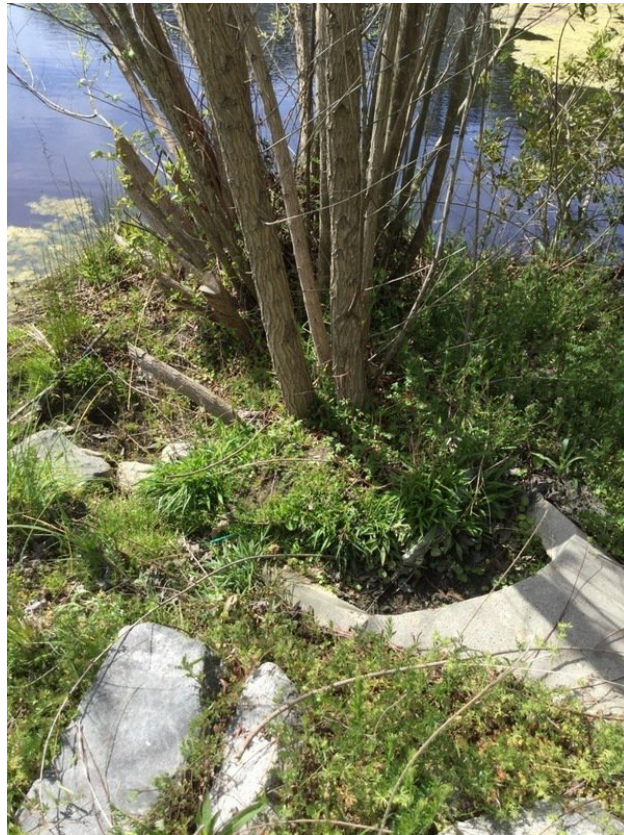
Inlet Defect Type Photo

Riser Principal Spillway Comment	Erosion on sides of riser F12509- 1023. Shown on field map as a storm inlet
5 - First Highest Riser Principal Spillway Score and Defect type	1 - Erosion
5 - First Highest Riser Principal Spillway Score	1
6 - INLET INSPECTED	Partial see comments
Vegetation	
Inlet Defect Type	Vegetation
Inlet ID	F12509-1055
Inlet Defect Type Score	3 = Serious condition. Immediate need for repair or replacement.

Overgrown vegetation blocking inlet

Inlet Comment	Overgrown vegetation blocking inlet . Shown on field map as a storm node
---------------	--

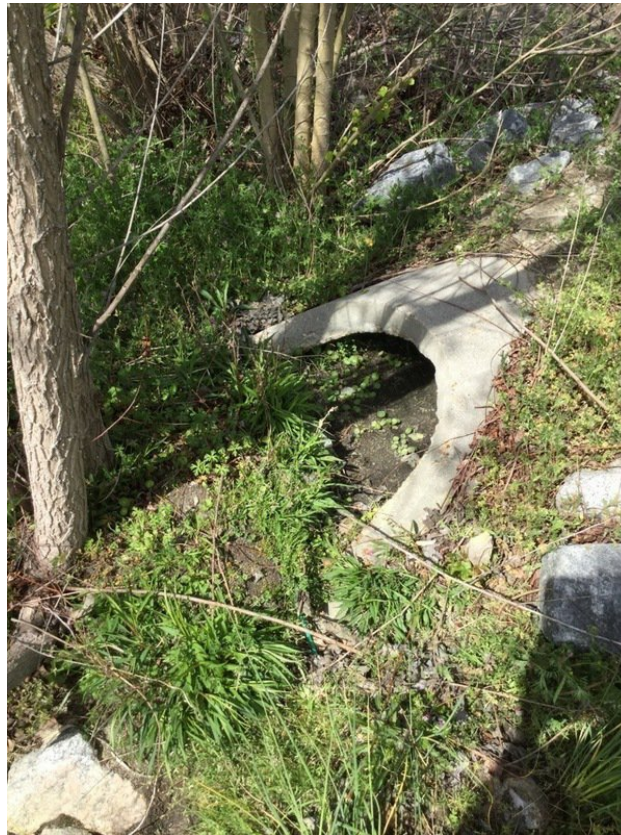
Inlet Defect Type Photo

Inlet Defect Type	Sedimentation
Inlet ID	F12509-1055
Inlet Defect Type Score	3 = Serious condition. Immediate need for repair or replacement.

8" sediment deposit depth in pipe
