SU147480000A, INDIAN RIVER FARMS LAKE #1, 979831, 2017-04-11

Overall Information

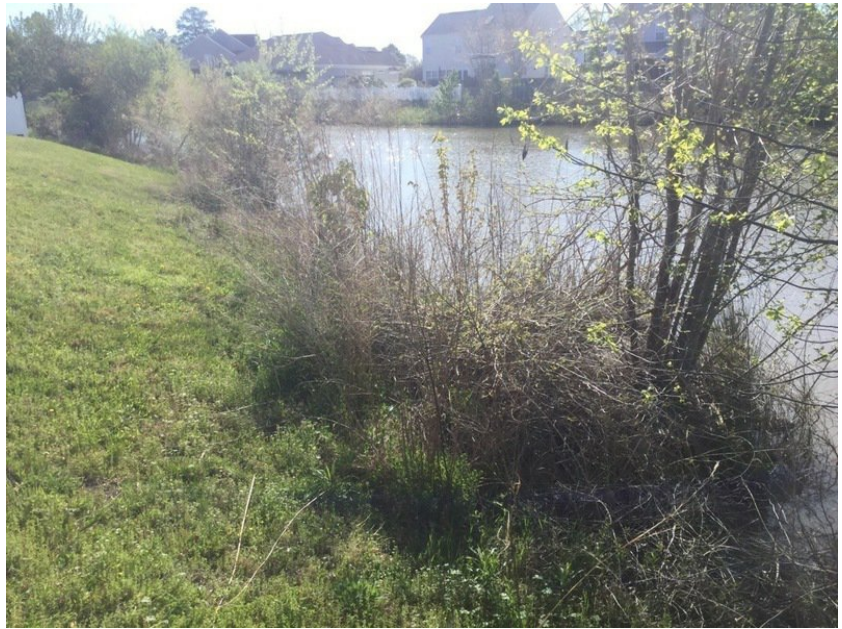
Pre-treatment Grass Filter Strip Defect Type Photo

Pre-treatment Grass Filter Strip Defect Type	Vegetation
Pre-treatment Grass Filter Strip Defect Type Score	2 = Degraded condition. Poorly maintained, routine maintenance and repairs needed.

Filter strip dominated by woody vegetation all along pond.

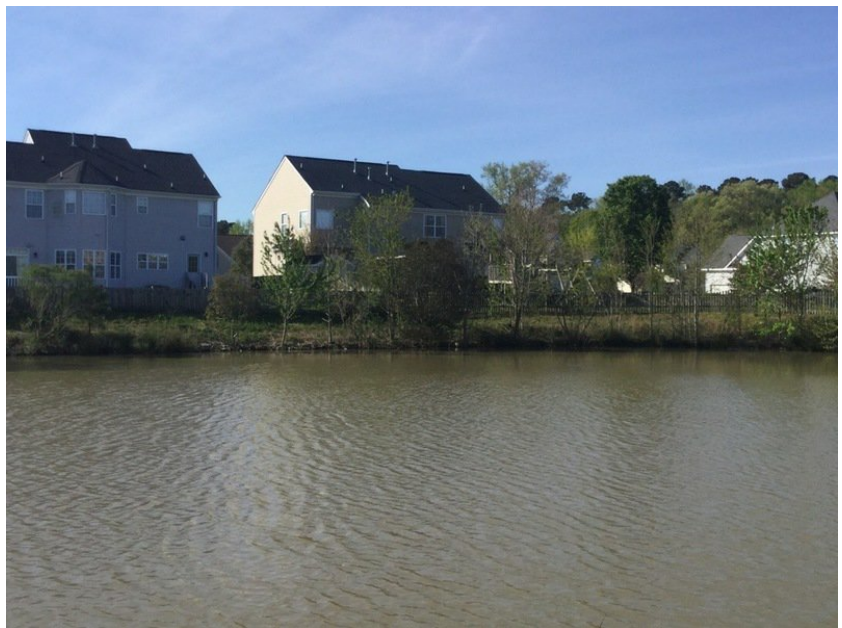
Side Slope Defect Type	Vegetation
Side Slope Defect Type Score	2 = Degraded condition. Poorly maintained, routine maintenance and repairs needed.
Side Slope Defect Type Photo

Trees and woody vegetation overgrown on slope around pond.

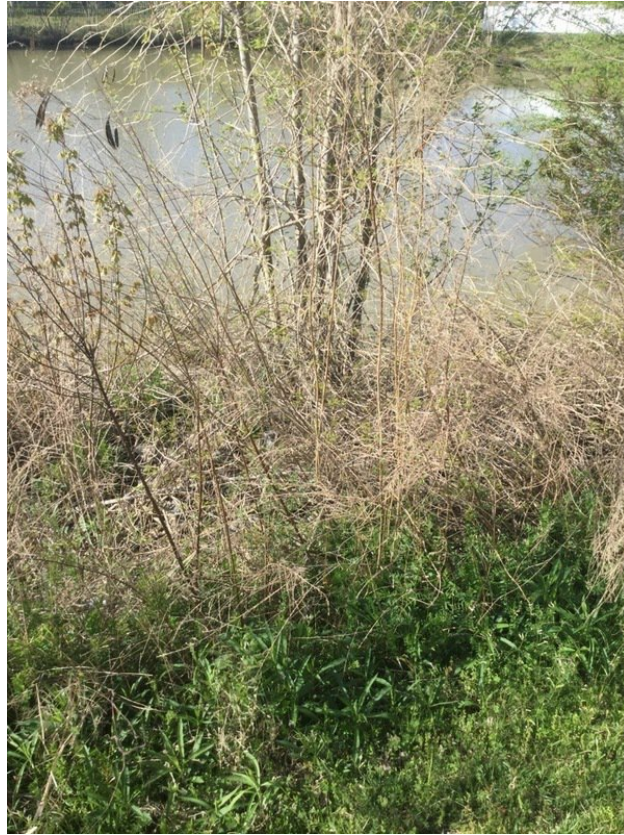
Inlet Defect Type Photo

Woody vegetation overgrown around pipe. No other visible defects.

Inlet Comment	Woody vegetation overgrown around pipe. No other visible defects. Shown on field map as a storm node
Inlet ID	F12509-1044
Inlet Defect Type Score	0 = Good condition. Well maintained, no action required.

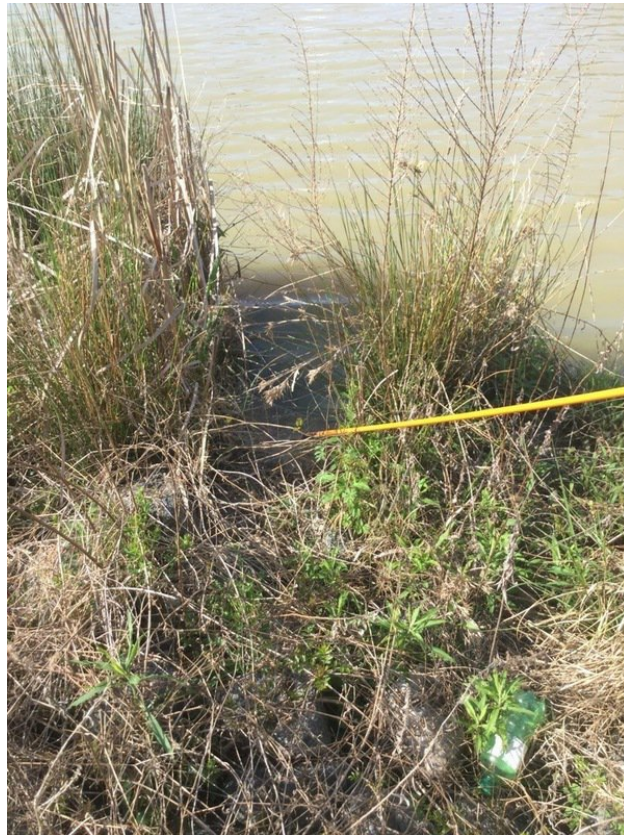
Inlet Defect Type Photo

Inlet overall in good condition. Probe used to locate inlet in picture. Shown on map as a storm node

Inlet overall in good condition. Probe used to locate inlet in picture. Shown on field map as a storm node

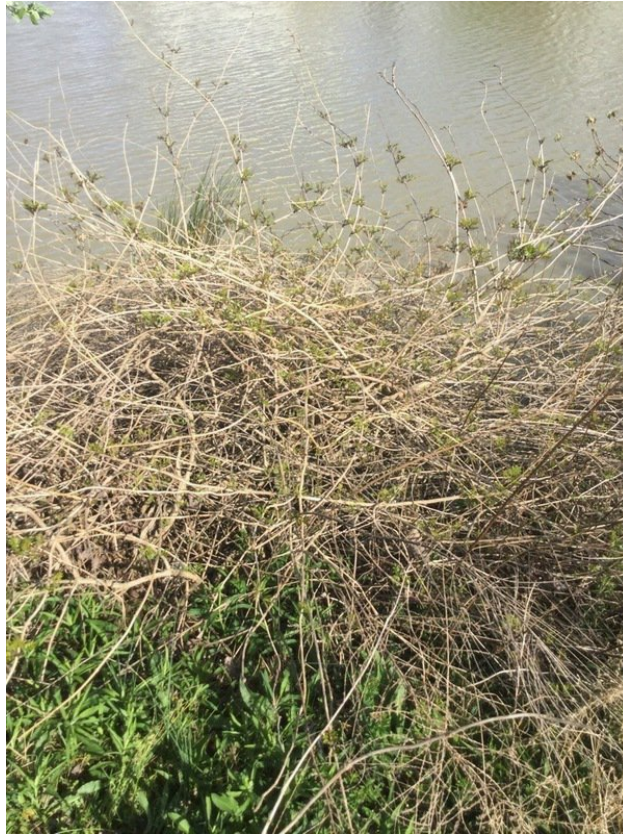
Inlet Defect Type Photo

Located inlet, but unable to assess due to woody vegetation overgrowth. Shown on map as a storm node

Located inlet, but unable to assess due to woody vegetation overgrowth. Shown on field map as a storm node

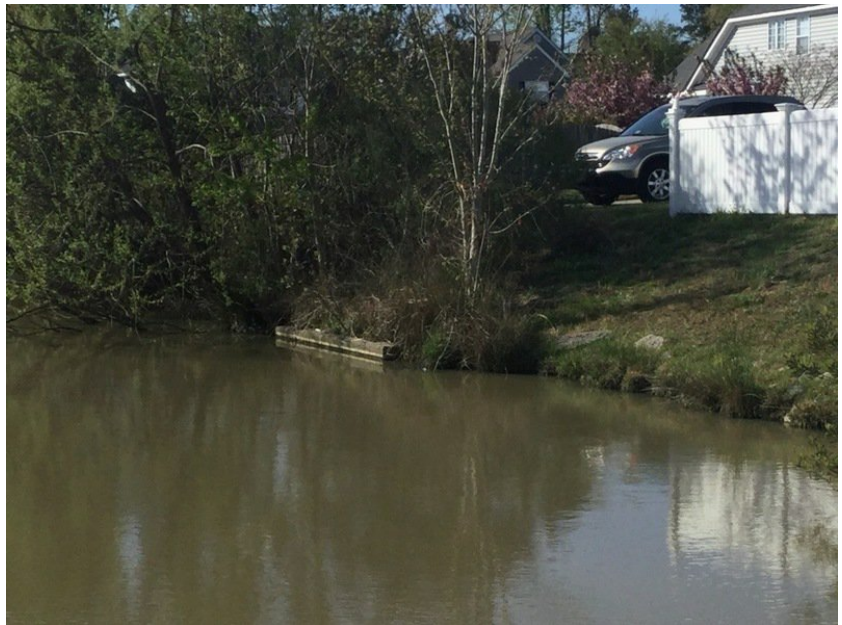
Inlet Defect Type Photo

Shown on field map as a storm node.

Structure mostly submerged, but looks to be in good condition. Connects to F12509-1036 from Indian River Farms Lake #2.
