SU147480000B, INDIAN RIVER FARMS LAKE #2, 979832, 2017-04-11

Overall Information

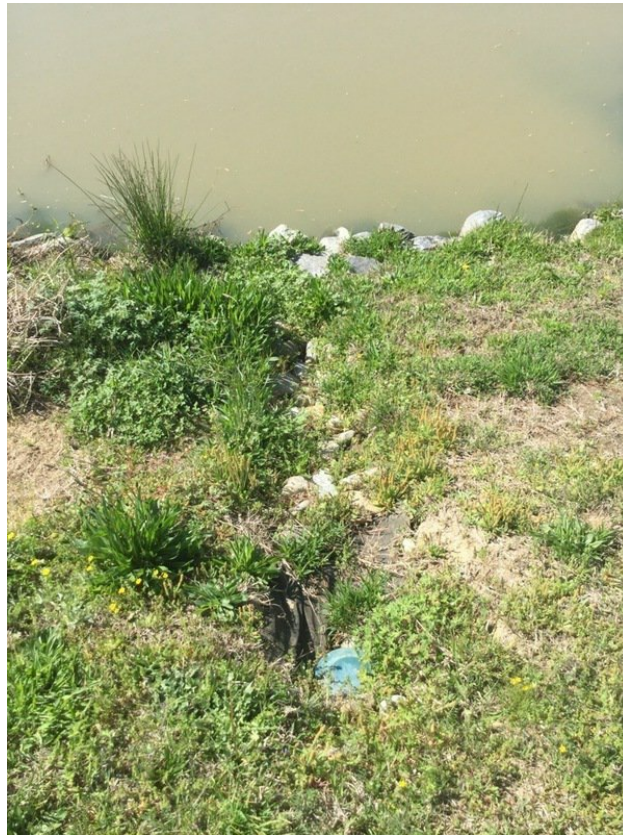
Structure built into slope. Possibly to drain private pool.

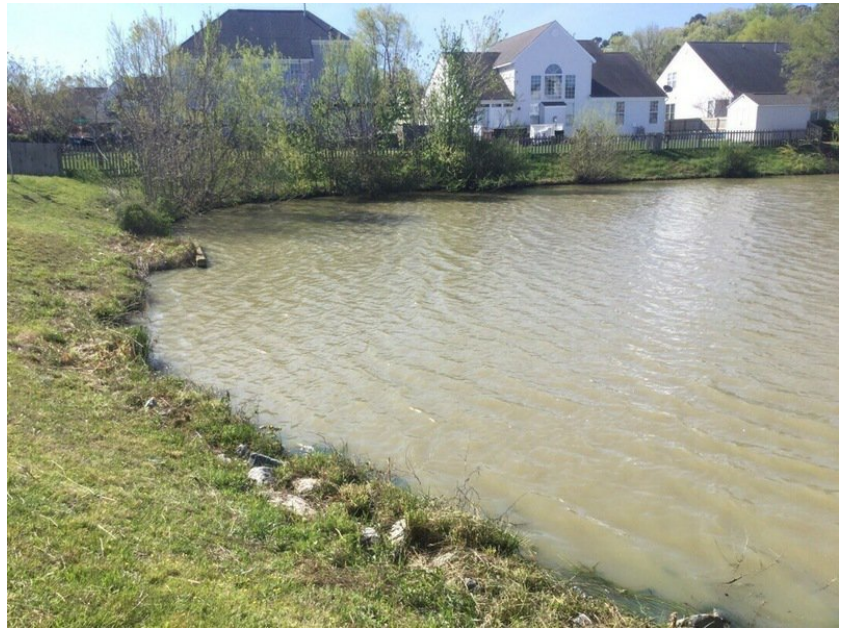
Pre-treatment Grass Filter Strip Defect Type	Vegetation
Pre-treatment Grass Filter Strip Defect Type Score	1 = Moderate condition. Adequately maintained, routine maintenance needed.

Grass filter strip cut too short along pond. It would seem to be in good condition if allowed to grow.

Pre-treatment Grass Filter Strip Comment	Filter strip sparse around pond
2 - First Highest Pre Treatment Grass Filter Strip Score and Defect type	1 - Vegetation
2 - First Highest Pre Treatment Grass Filter Strip Score	1
3 - SIDE SLOPE INSPECTED	Yes

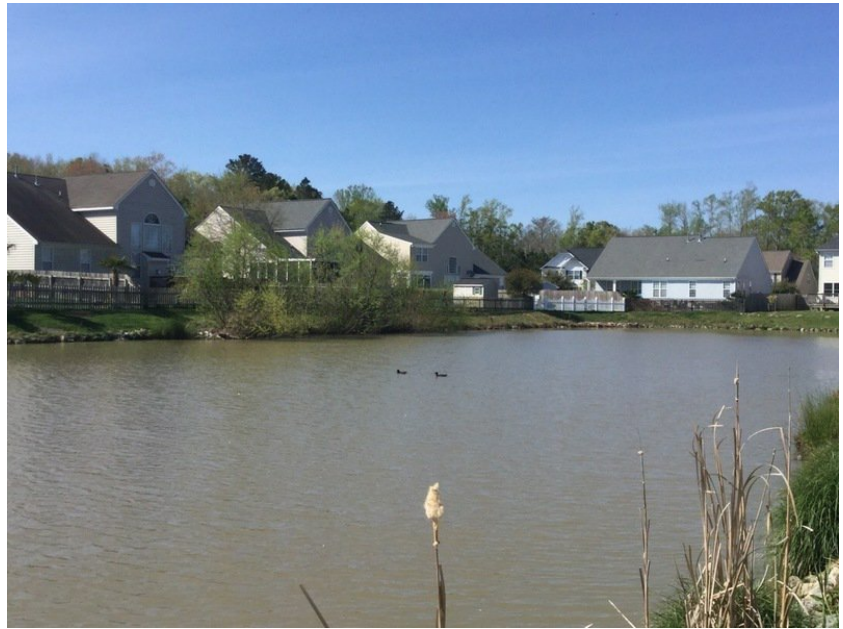
Side Slope Defect Type	Vegetation
Side Slope Defect Type Score	1 = Moderate condition. Adequately maintained, routine maintenance needed.

Woody vegetation in several areas along slope of pond.

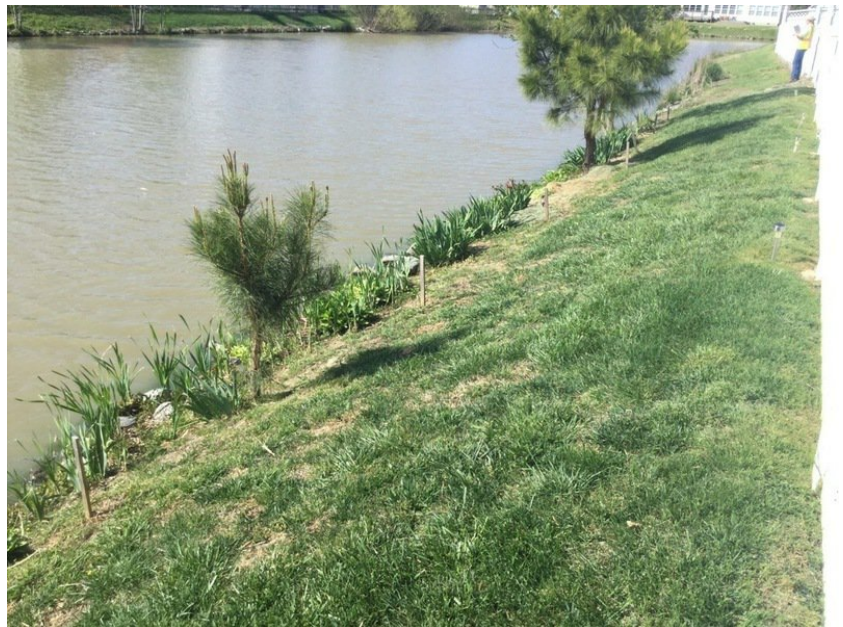
1 = Moderate condition. Adequately maintained, routine maintenance needed.

Patches of bare soil in some locations around

Patches of bare soil in some locations around pond.

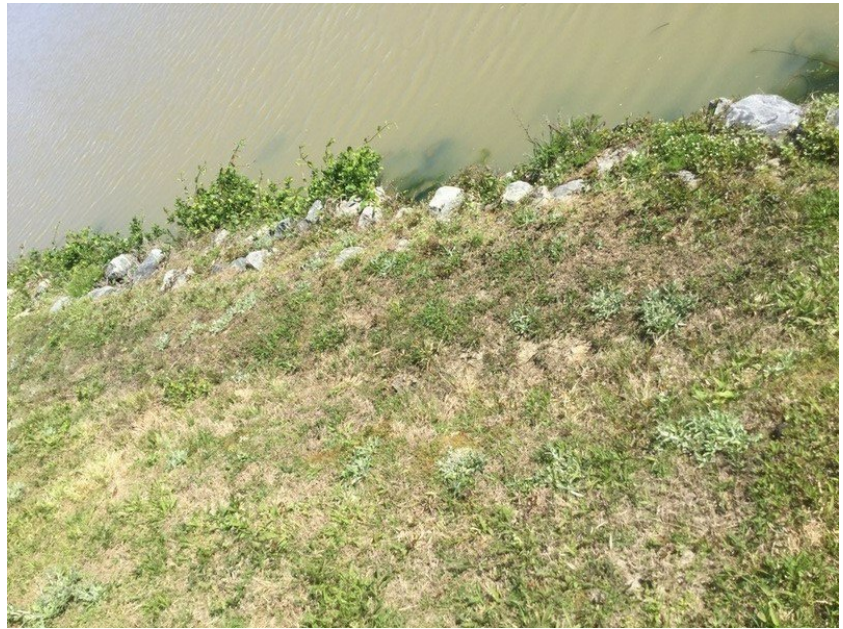
1 = Moderate condition. Adequately maintained, routine maintenance needed.

Some carving of the slope near the end of the pond at the riser spillway.

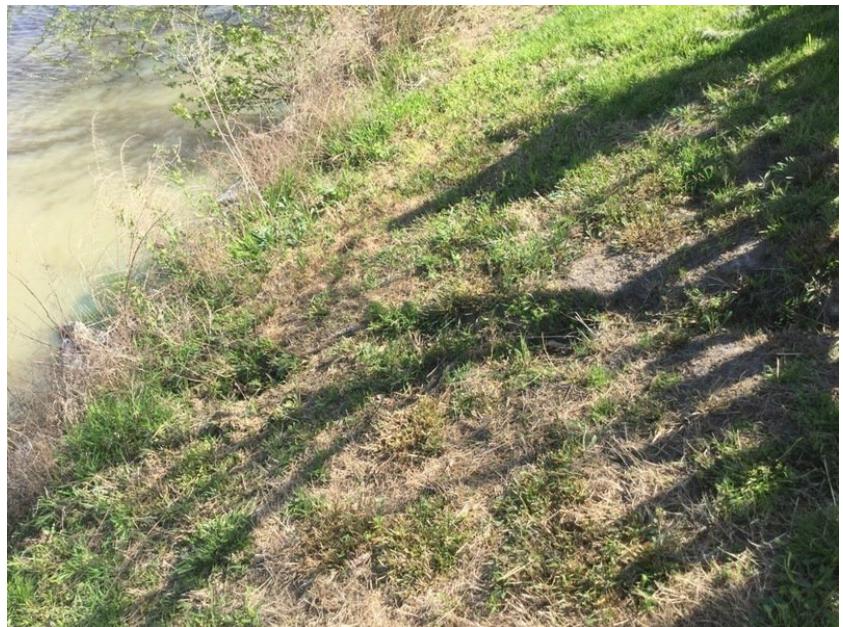
1 = Moderate condition. Adequately maintained, routine maintenance needed.

Flow channel leading to sinkhole on slope.

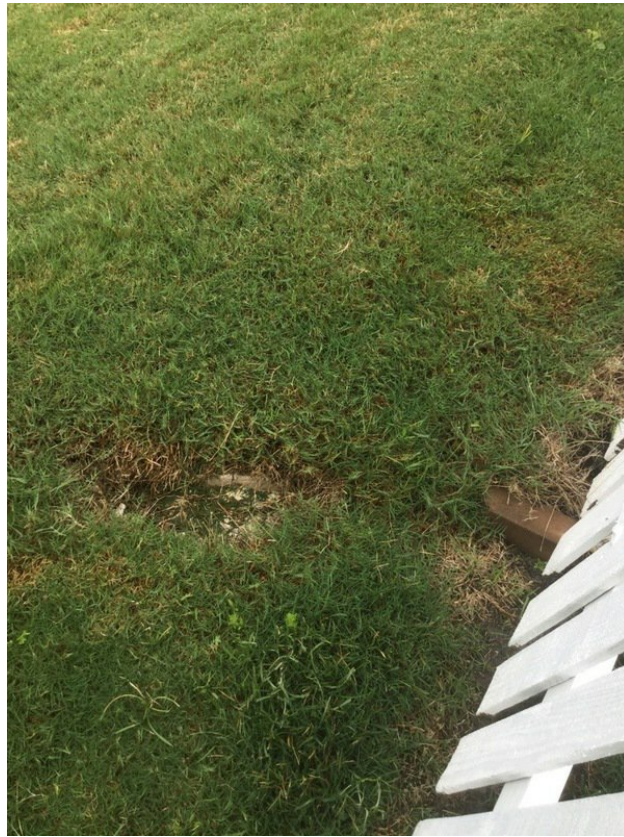
2 = Degraded condition. Poorly maintained, routine maintenance and repairs needed.

6" deep erosion hole on the side slope

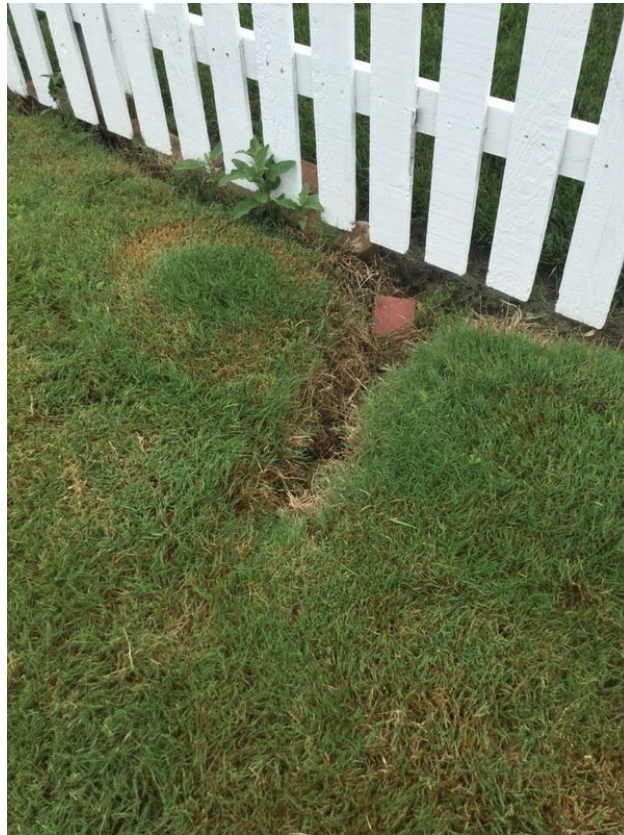
2 = Degraded condition. Poorly maintained, routine maintenance and repairs needed.

6" deep erosion hole on the side slope

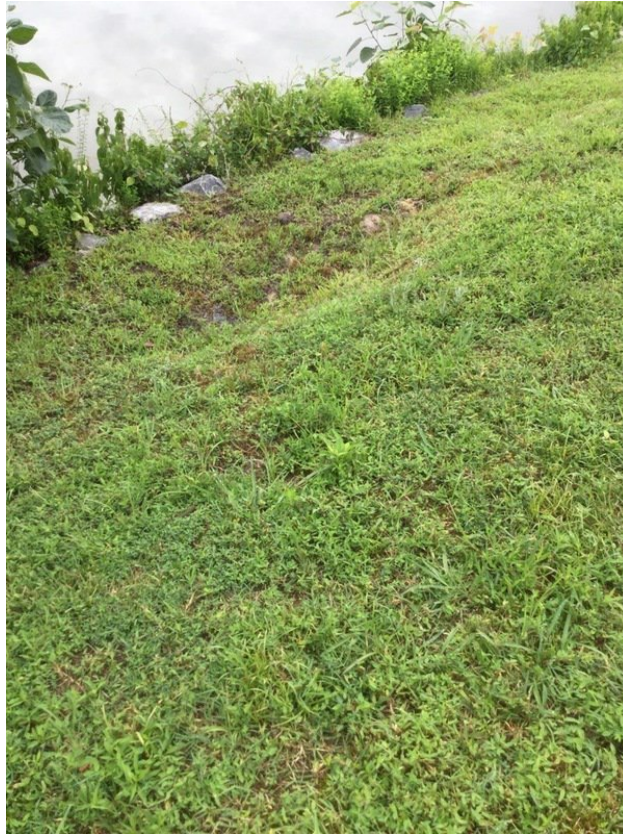
2 = Degraded condition. Poorly maintained, routine maintenance and repairs needed.

Large depression on side slope

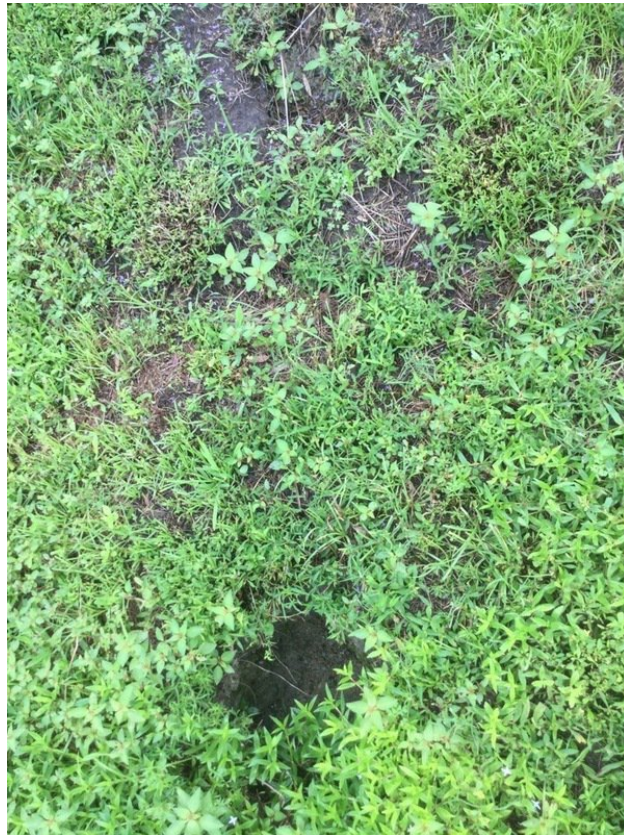
2 = Degraded condition. Poorly maintained, routine maintenance and repairs needed.

Side Slope Comment	24" hole in side slope with upstream bank erosion.
3 - First Highest Side Slope Score and Defect type	2 - Erosion
3 - First Highest Side Slope Score	2
4 - EMBANKMENT INSPECTED	N/A
4 - First Highest Embankment Score and Defect Type	0 -
4 - First Highest Embankment Score	0
5 - RISER PRINCIPAL SPILLWAY INSPECTED	Yes
Riser Principal Spillway Defect Type Score	0 = Good condition. Well maintained, no action required.
Riser Principal Spillway Comment	F12509-1025 Shown on field map as a storm node.
5 - First Highest Riser Principal Spillway Score and Defect type	0 -
5 - First Highest Riser Principal Spillway Score	0
6 - INLET INSPECTED	Partial see comments
Inlet ID	F12509-1036

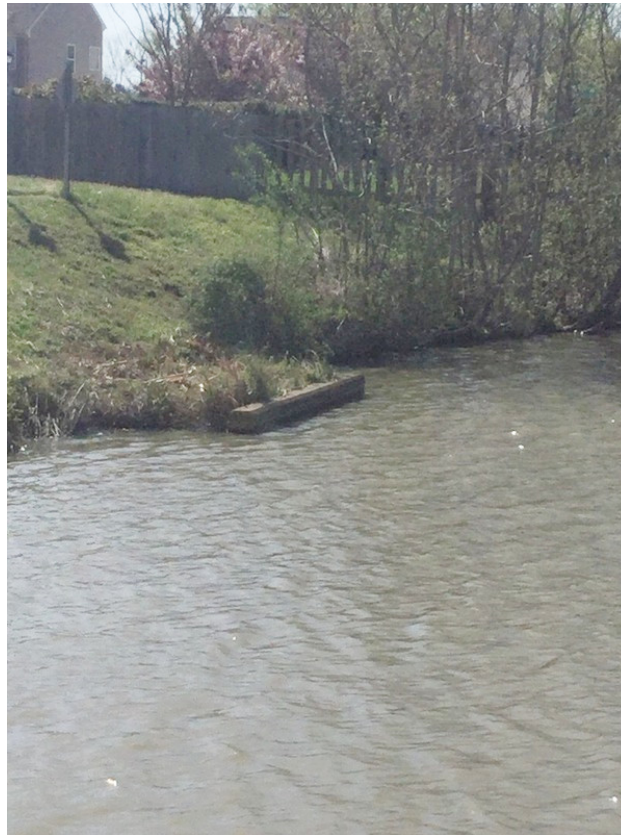
Structure submerged, but looks to be in good condition. Shown on map as a storm node.

Inlet Comment	Structure mostly submerged, but looks to be in good condition. Connects to F12509-1037 from Indian River Farms Lake #1. Shown on field map as a storm node.
Inlet ID	F12509-1000
Inlet Comment	Unable to locate pipe. Located upstream manhole, asset number not indicated on map. Shown on field map as a storm node.
Inlet ID	F12509-1030
Inlet Comment	Submerged. Unable to locate locate inlet with probe. Located upstream storm drain F12509-1031. Shown on field map as a storm node.
Inlet ID	F12509-1026
Inlet Comment	Submerged. Able to locate with probe, but unable to inspect. Shown on field map as a storm node.
Inlet ID	F12509-1057
Inlet Comment	Able to locate with probe. Unable to inspect because submerged. Shown on field map as a storm node.

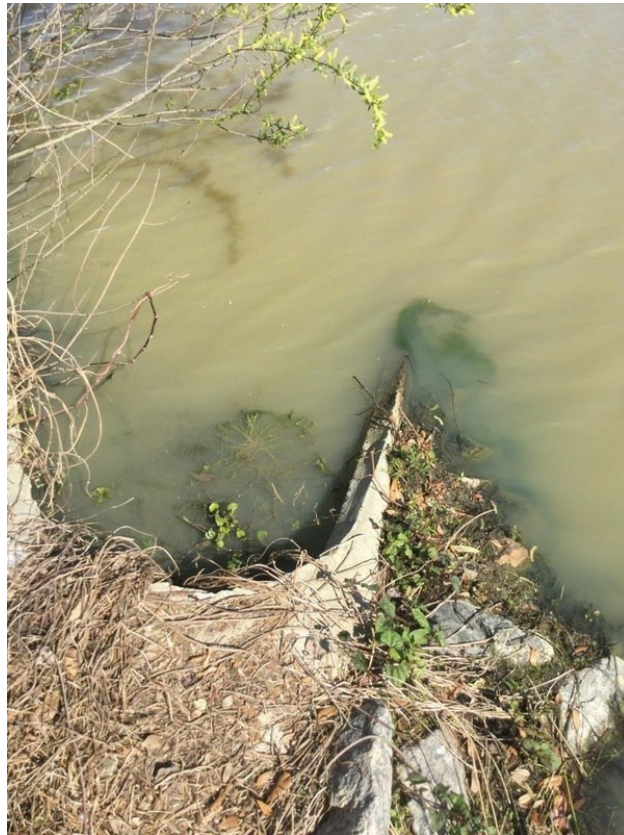
Inlet Defect Type	Vegetation
Inlet ID	F12509-1033
Inlet Defect Type Score	1 = Moderate condition. Adequately maintained, routine maintenance needed.

Aquatic vegetation growing inside of pipe. Also, woody vegetation growing around outside of pipe. Shown on map as a storm node.

Inlet Comment	Aquatic vegetation growing inside of inlet F12509-1033. Also, woody vegetation growing around outside of pipe. Shown on field map as a storm node.
6 - First Highest Inlet Score and Defect type	1 - Vegetation
6 - First Highest Inlet Score	1
7 - OUTLET INSPECTED	N/A
7 - First Highest Outlet Score and Defect type	0 -
7 - First Highest Outlet Score	0
8 - OVERFLOW EMERGENCY SPILLWAY INSPECTED	N/A
8 - First Highest Overflow Emergency Spillway Score and Defect type	0 -
8 - First Highest Overflow Emergency Spillway Score	0
Routine SWMF	Yes
Repairs Needed	Yes
